**ALABAMA HAZARDOUS WASTES MANAGEMENT AND MINIMIZATION ACT  
(AHWMMA)**

**Compliance Evaluation Inspection (CEI) Report**

Zilkha Biomass Selma LLC  
1256 County Road 78  
Selma, Dallas County, Alabama 36703

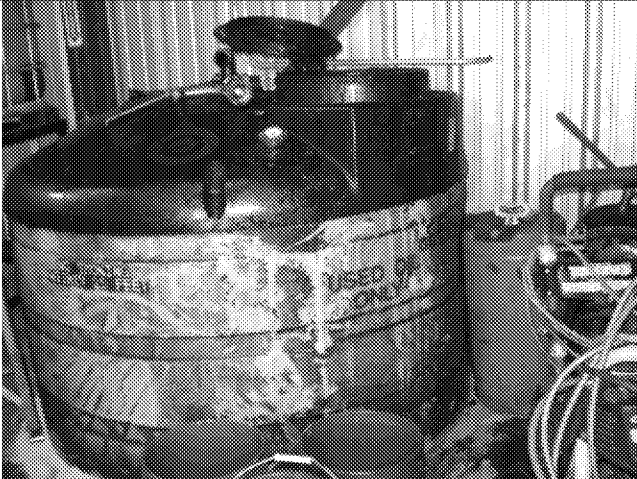
8. Used oil tank

In the warehouse, we saw a 385-gallon polyethylene used oil container. It was marked with the words "Used Oil", but the lid was open. The container and the concrete floor around it were stained with spilled oil; oil dry was spread around the container to absorb the spill, but it had not been removed. On the floor beside the large container, we also saw a 5-gallon plastic bucket of used oil; it was open, was not marked in any way, and was about half-filled with used oil. Elsewhere in the warehouse, we saw a fiber container that held approximately twenty spent fluorescent lamps and several high-intensity discharge lamps. Some of the lamps were broken, the container was not visibly marked, and was not closed or dated. Mr. Shields did not know how long the lamps had been accumulated at the site. See Photograph #8 through Photograph #10.

- There was a significant release of liquid from the scrubber unit; ZBS has not made a hazardous waste determination on that liquid.
- ZBS did not keep closed to containers holding used oil
- ZBS did not mark one of those containers with the words "Used Oil"
- ZBS has not made a hazardous waste determination on its spent lighting waste
- ZBS has not notified the Department of its used oil generation.

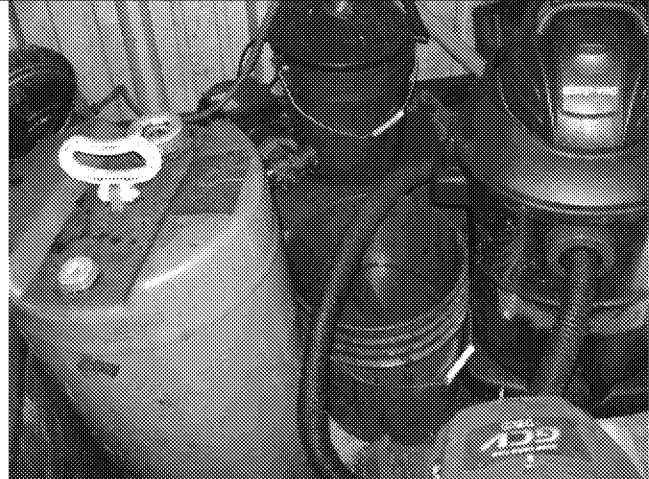
9. Used oil container

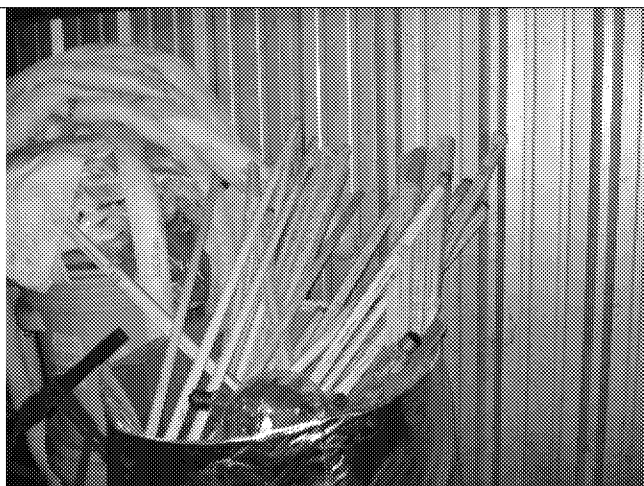
10. Discarded fluorescent lamps

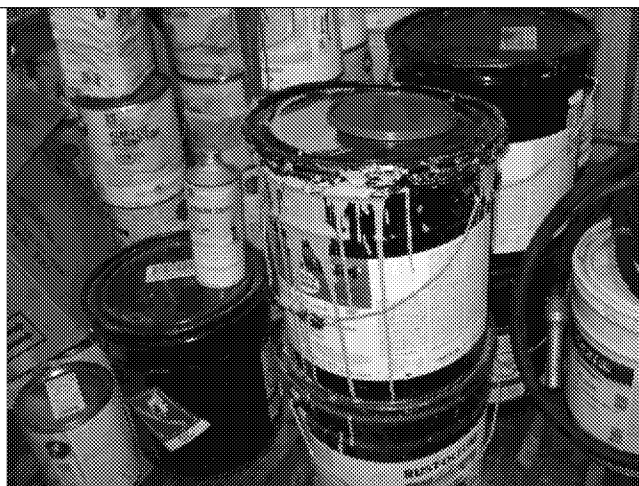
11. Paint

In one of the storage trailers, we saw five cans of paint that were stained with paint and were not tightly closed. Mr. Shields did not know if they still held useable paint. See Photograph #11.
